# Sample Pre Purchase Building And Pest Reports

## Apexi Building Inspections Pty Ltd

Report/Agreement # 2707251415093

### Pest And Building Inspection

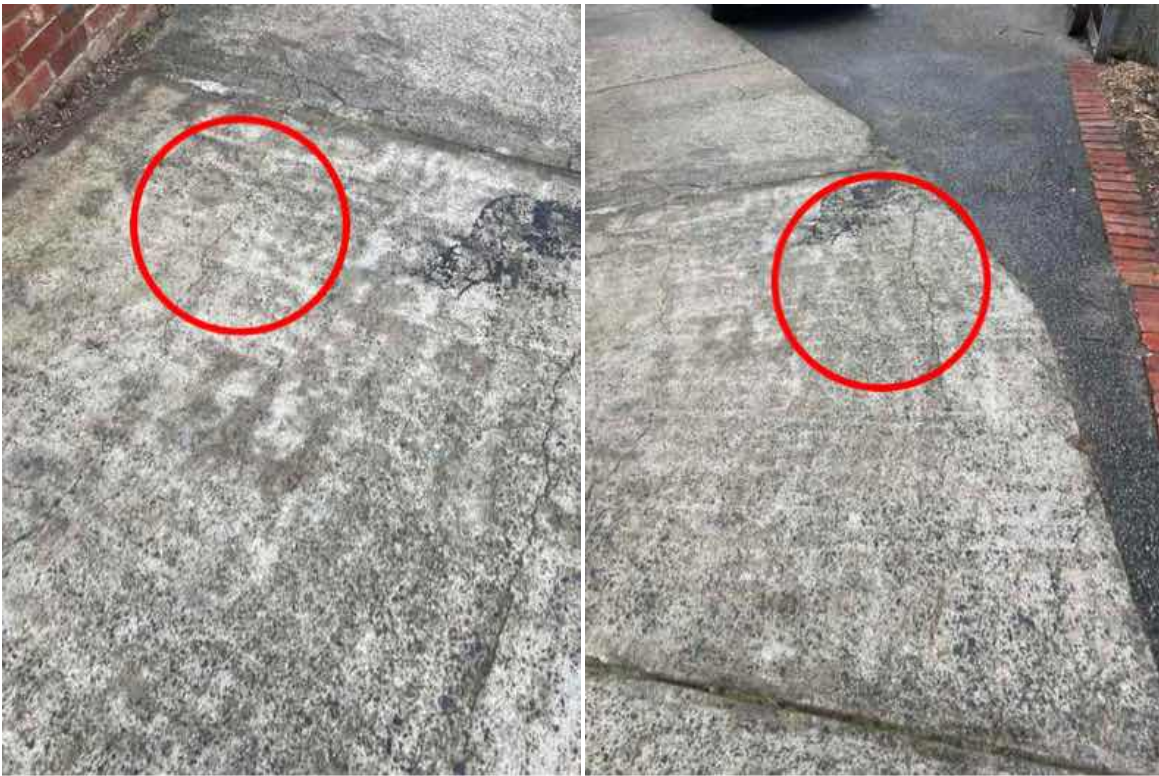
Common cracks were observed on the driveway. Whilst these cracks appeared to be typical at the time of inspection, we strongly recommend you monitor these cracks and if worsening occurs contact a concreter for further advice.

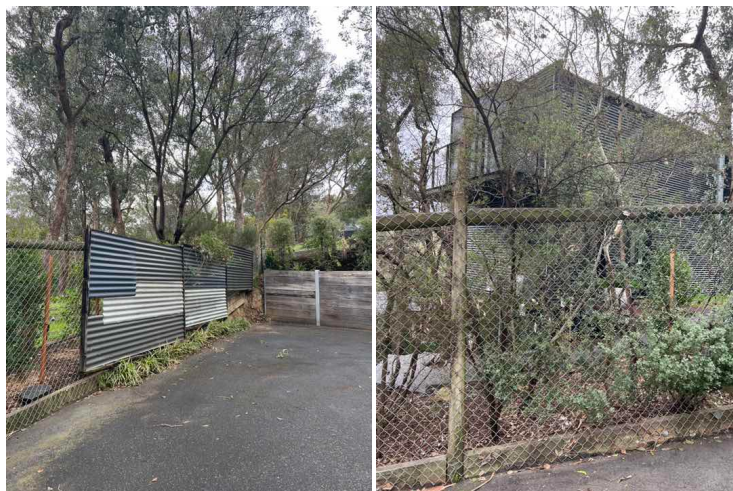
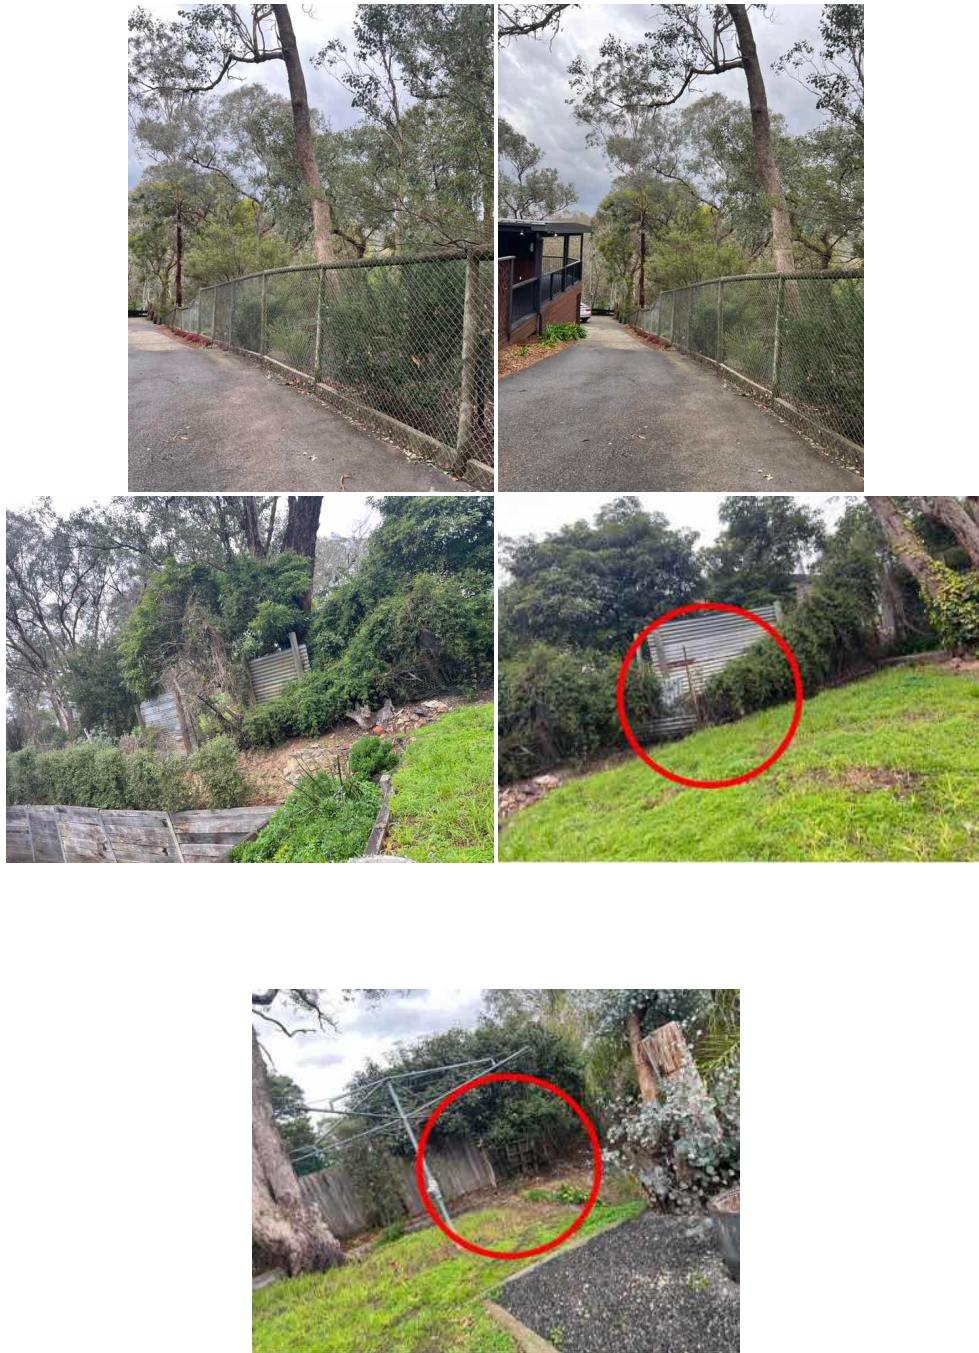
General age to fence components. General upkeep and maintenance required. A qualified fencing contractor should be engaged for repairs.

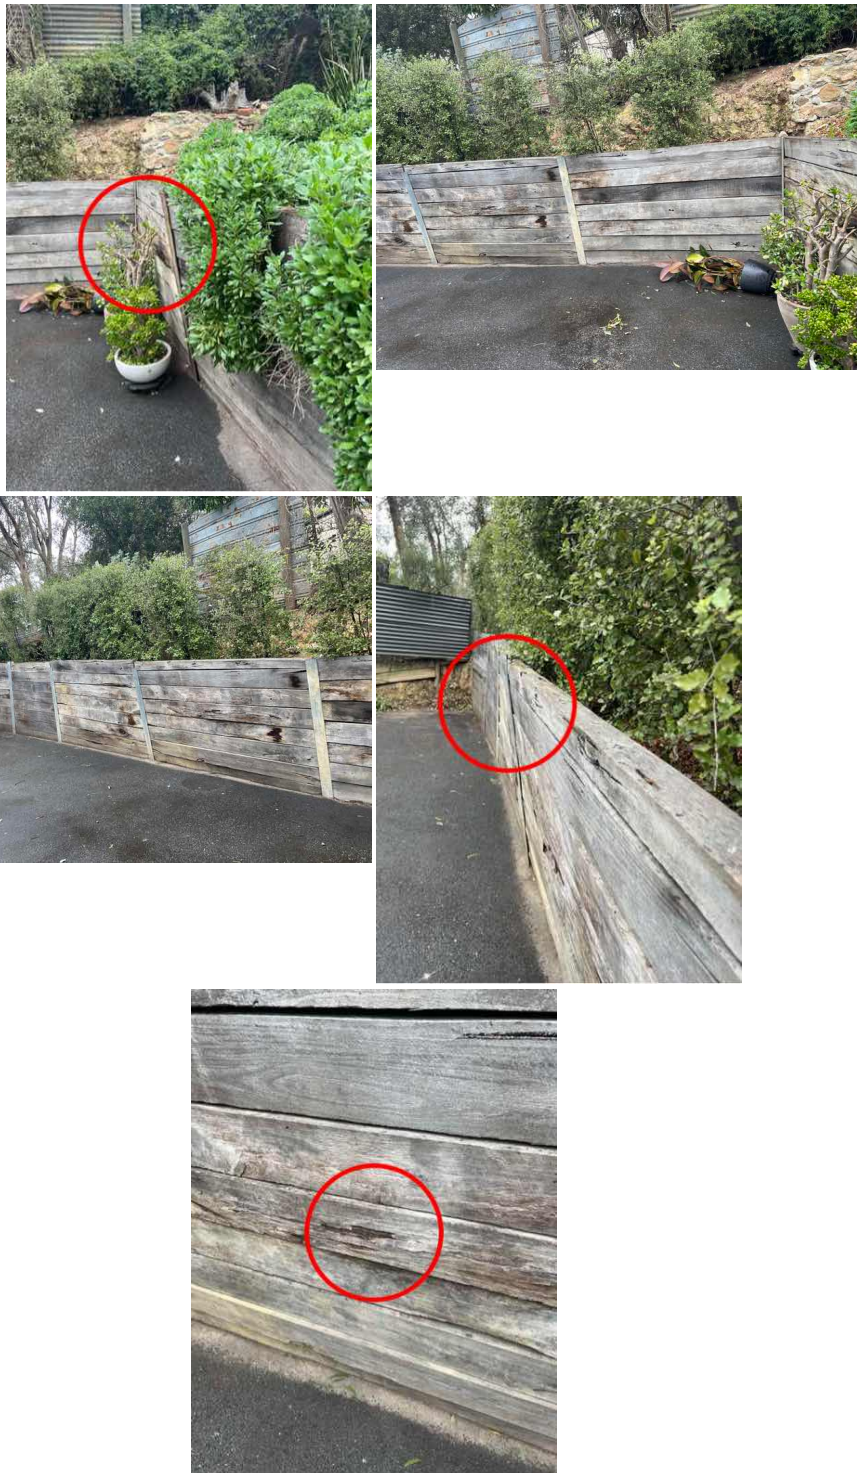
| Section | Location | Name | Comment |
|---|---|---|---|
| SITE & CONCRETED AREAS | Retaining Walls | Overall Condition | Retaining wall leaning due to deterioration and age. A qualified brick layer should be engaged for advice and recommendations. |
| SITE & CONCRETED AREAS | Retaining Walls | Overall Condition | Timber fungal decay evident. Recommendations: A qualified landscaping contractor should be engaged for repairs and recommendations. |

Retaining wall leaning due to deterioration and age. A qualified brick layer should be engaged for advice and recommendations.

Timber fungal decay evident. Recommendations: A qualified landscaping contractor should be engaged for repairs and recommendations.

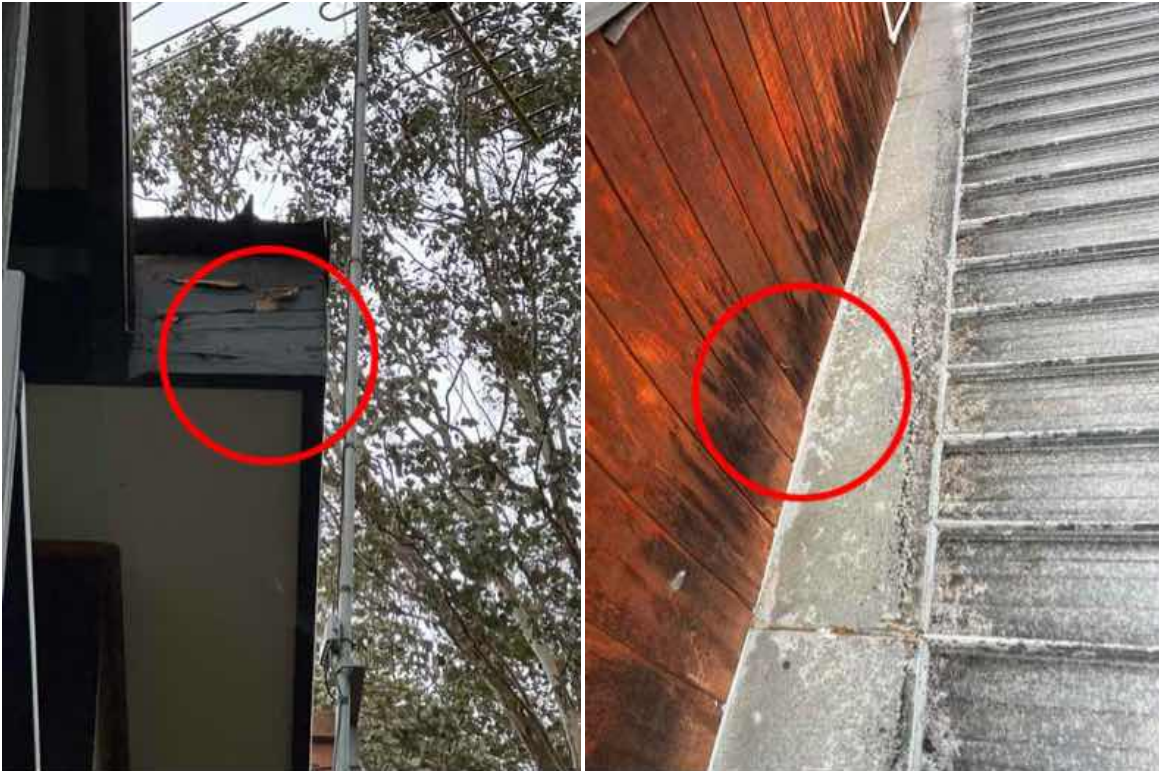
| Section | Location | Name | Comment |
|---|---|---|---|
| EXTERIOR | Front Elevation | Defects Findings | Damaged Weatherboard Cladding noted. Contact a qualified carpenter for assistance. |
| EXTERIOR | Front Elevation | Defects Findings | Upon visual inspection, the fascia board paint is deteriorated, showing signs of peeling and cracking. This condition may lead to moisture intrusion and wood decay. It is recommended to have a suitably licensed or qualified tradesperson sand down the affected areas, apply a primer, and repaint with a high-quality exterior paint to protect the fascia board from further damage. Regular maintenance is advised. |

Damaged Weatherboard Cladding noted. Contact a qualified carpenter for assistance.

Upon visual inspection, the fascia board paint is deteriorated, showing signs of peeling and cracking. This condition may lead to moisture intrusion and wood decay. It is recommended to have a suitably licensed or qualified tradesperson sand down theaffected areas, apply a primer, and repaint with a high-quality exterior paint to protect the fascia board from further damage. Regular maintenance is advised.

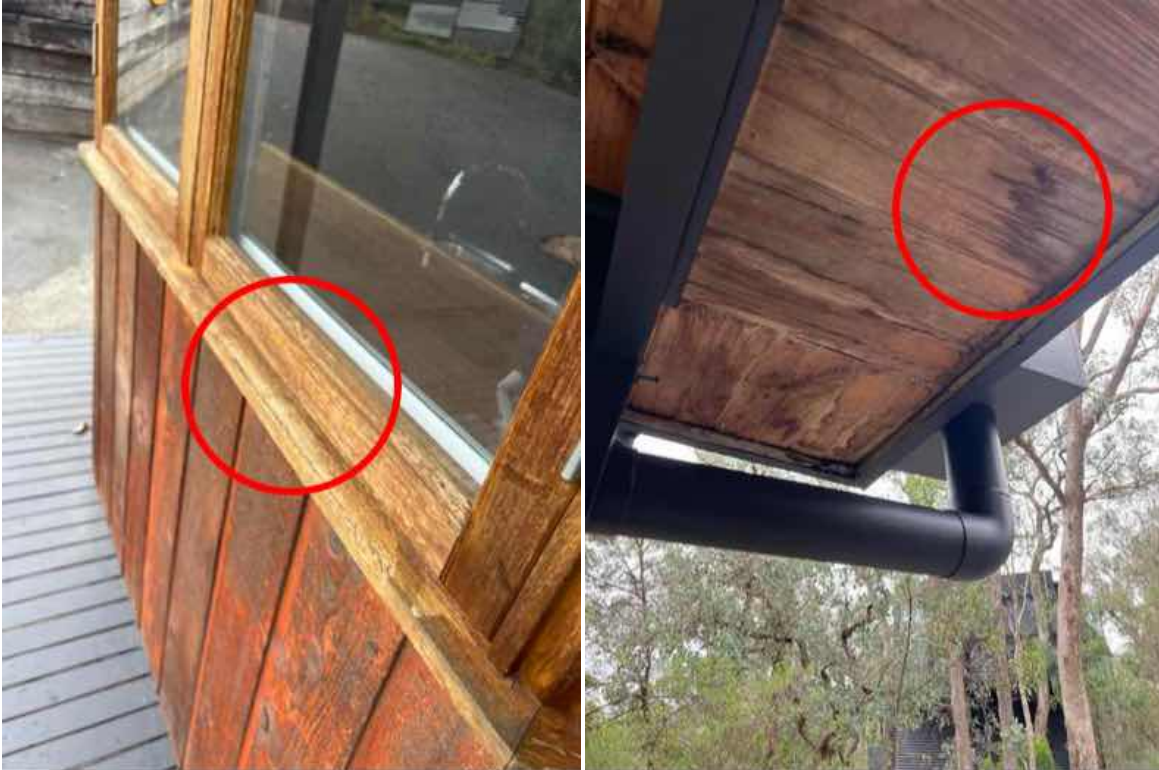
| Section | Location | Name | Comment |
|---|---|---|---|
| EXTERIOR | Left Elevation | Defects Findings | Upon visual inspection, the window frame shows signs of paint deterioration, including peeling and cracking. This can lead to moisture ingress and potential wood damage. It is recommended to have a suitably licensed or qualified tradesperson sand down the affected areas, apply a primer, and repaint with weather-resistant paint to protect the frame and extend its lifespan. Regular maintenance checks are advised. |
| EXTERIOR | Left Elevation | Defects Findings | Upon visual inspection, a dry stain was observed on the eave, though moisture readings were normal. This suggests a past leak or condensation issue. It is recommended to have a licensed tradesperson assess the area to ensure there are no underlying issues with the roofing or gutter system and to perform any necessary repairs to prevent future water intrusion. |

Upon visual inspection, the window frame shows signs of paint deterioration, including peeling and cracking. This can lead to moisture ingress and potential wood damage. It is recommended to have a suitably licensed or qualified tradesperson sand down the affected areas, apply a primer, and repaint with weather-resistant paint to protect the frame and extend its lifespan. Regular maintenance checks are advised.

Upon visual inspection, a dry stain was observed on the eave, though moisture readings were normal. This suggests a past leak or condensation issue. It is recommended to have a licensed tradesperson assess the area to ensure there are no underlying issues with the roofing or gutter system and to perform any necessary repairs to prevent future water intrusion.

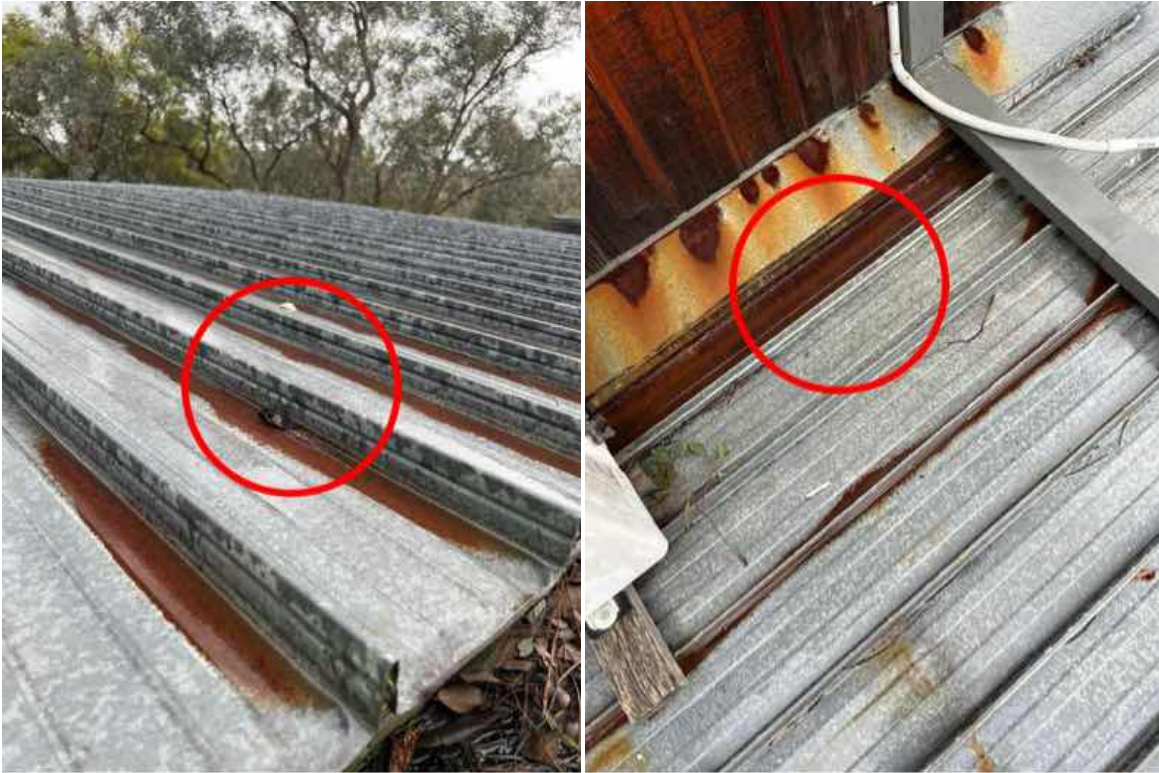
| Section | Location | Name | Comment |
|---|---|---|---|
| ROOF AND GUTTER | Roof Covering | Roof Clad Condition | Metal roof is rusting and requires or replacement as the may lead to water ingress into the roof cavity. Contact a qualified roofing contractor for immediate repairs. |

Metal roof is rusting and requires or replacement as the may lead to water ingress into the roof cavity. Contact a qualified roofing contractor for immediate repairs.

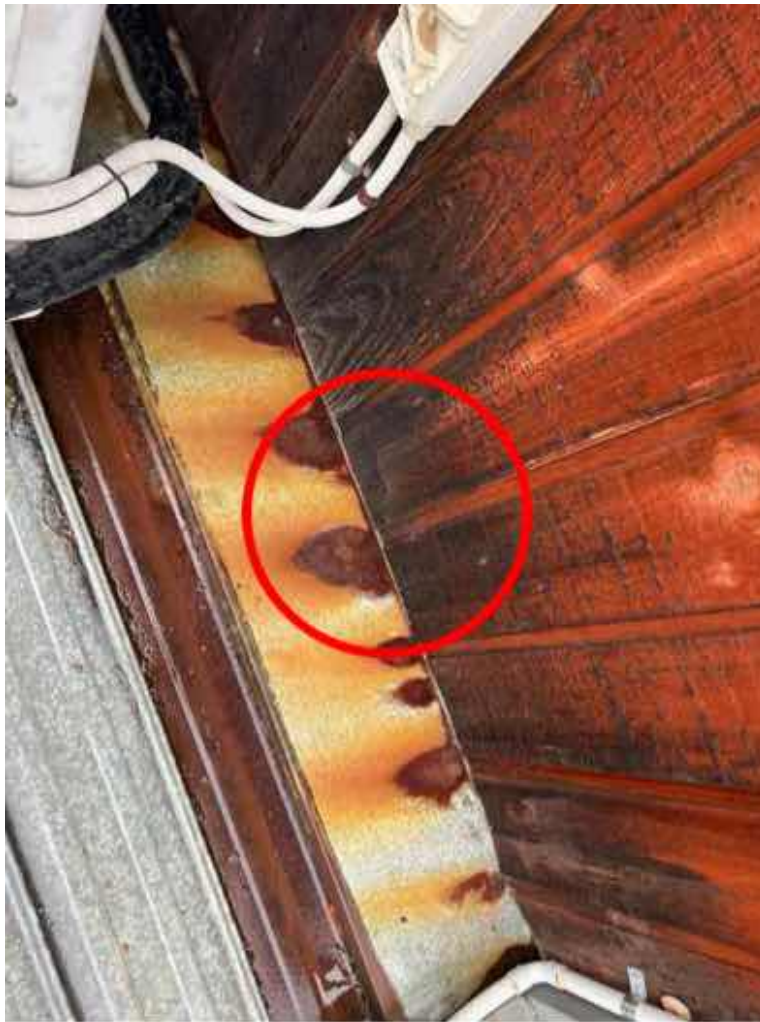
| Section | Location | Name | Comment |
|---|---|---|---|
| ROOF AND GUTTER | Roof Covering | Flashing Conditions | Minor flashing rust sections. A qualified roofer should be engaged for repairs and recommendations. |

Minor flashing rust sections. A qualified roofer should be engaged for repairs and recommendations.

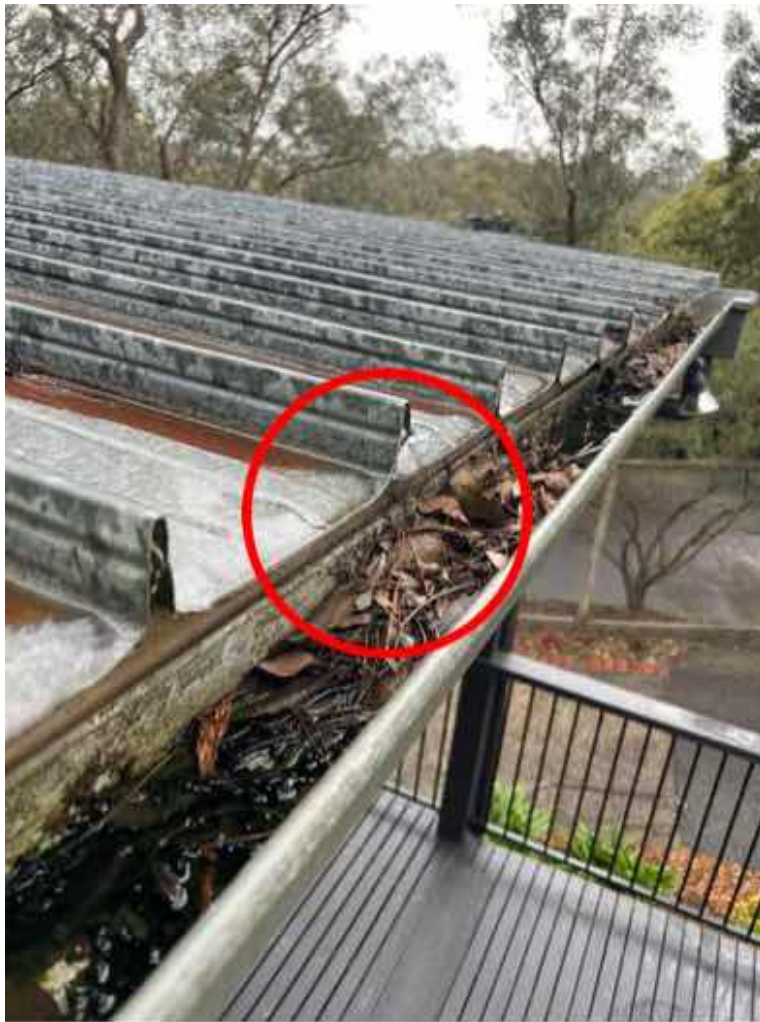
| Section | Location | Name | Comment |
|---|---|---|---|
| ROOF AND GUTTER | Guttering | Gutter Findings | Debris in guttering areas- this requires cleaning out to prevent blocking of downpipes and leaking into eaves and fascia. Have gutters cleaned and assessed by a plumber for adequate fall. Regularly clean to prevent ponding. Ponding water will contribute to rust. |

Debris in guttering areas- this requires cleaning out to prevent blocking of downpipes and leaking into eaves and fascia. Have gutters cleaned and assessed by a plumber for adequate fall. Regularly clean to prevent ponding. Ponding water will contribute to rust.

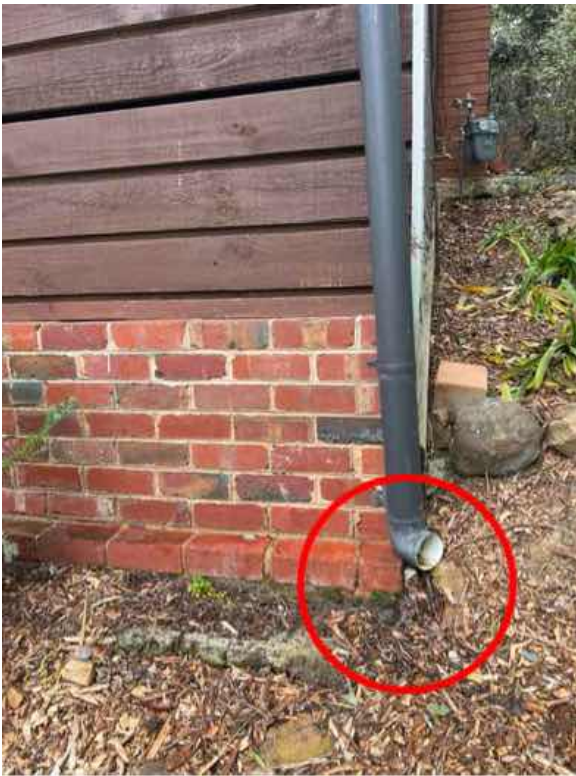
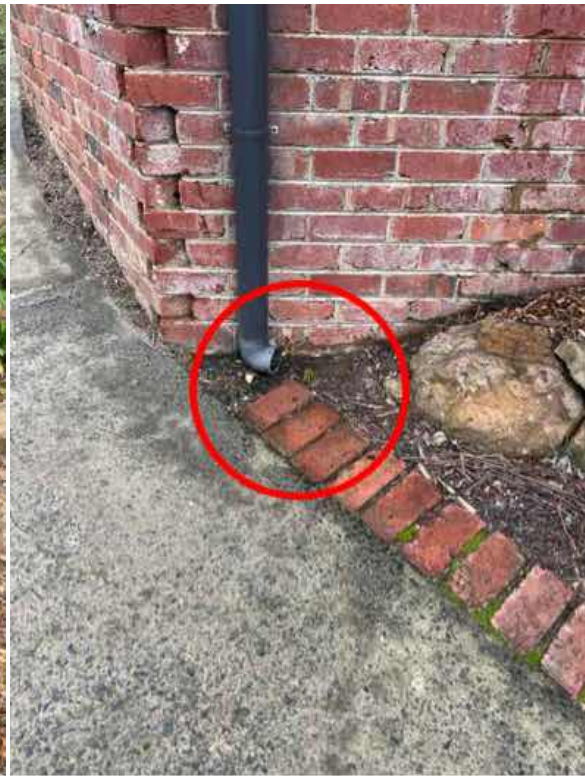
| ROOF AND GUTTER | Downpipes | Downpipe Findings | Downpipe/s not connected to storm water discharge - Downpipes not connected to storm water have the potential to cause differential settlement to the footings, cause rising damp and is also conducive to termite infestation. A qualified roof plumber should be engaged for advice and recommendations. |

Downpipe/s not connected to storm water discharge - Downpipes not connected to storm water have the potential to cause differential settlement to the footings, cause rising damp and is also conducive to termite infestation. A qualified roof plumber should be engaged for advice and recommendations.

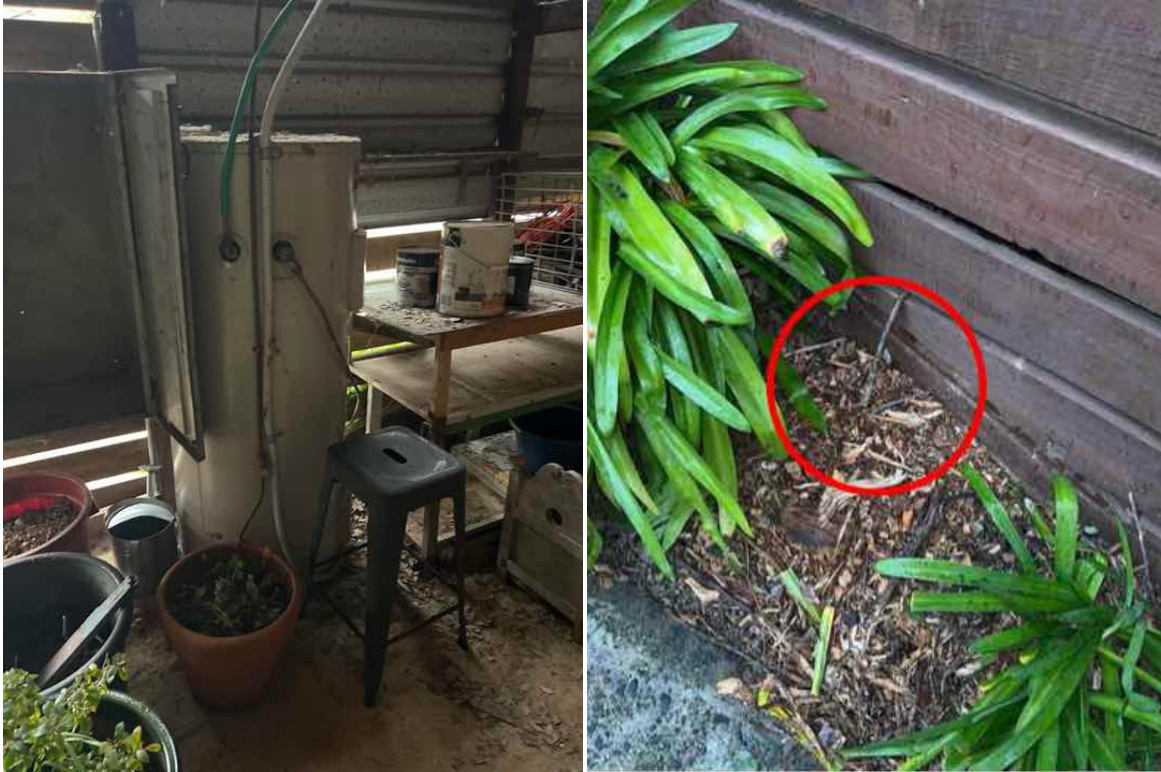
The hot water overflow requires diverting to a drain or further from the dwellings wall or footings. Excess water ponding alongside walls and into perimeter footings has the potential to cause rising damp, differential settlement and wall cracks over time. It is also conducive to termite infestation. Recommendations: Engage a plumber to rectify.

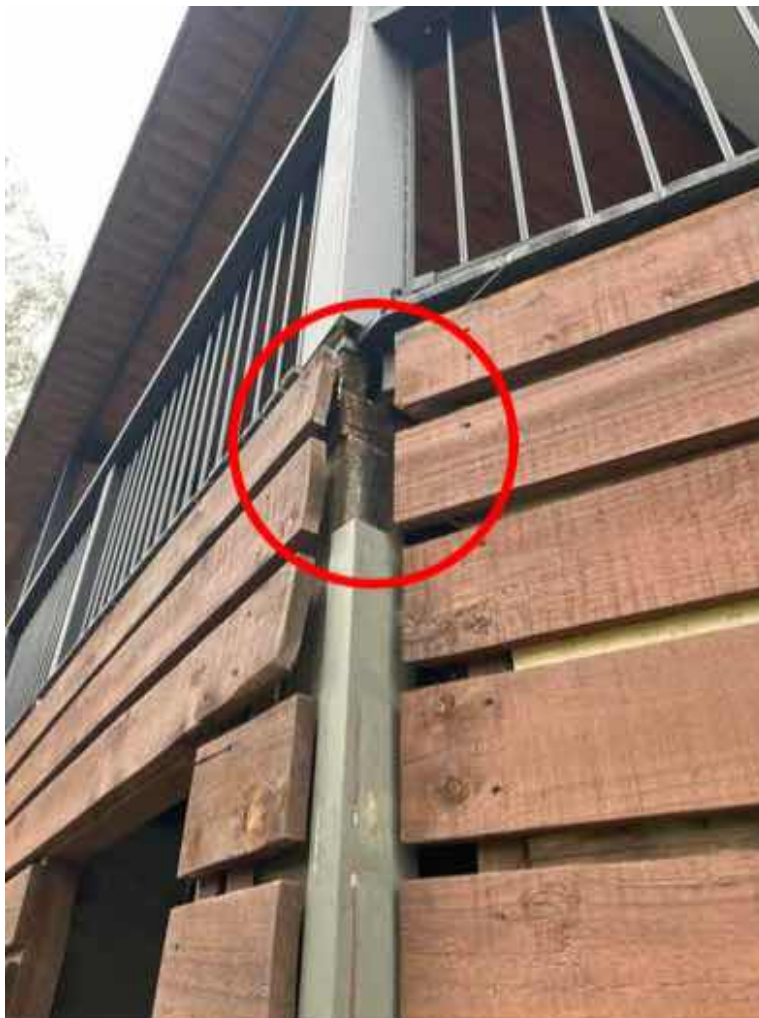
| STAIRS-PERGOLA-BALCONIES-DECKS | Decking Findings | Decking Posts | Post base timber fungal decay. Repairs as required. It is preferable to have posts on stirrups kept out of contact with soil. Timber in contact with ground is conducive to termite infestation and timber fungal decay. |

Post base timber fungal decay. Repairs as required. It is preferable to have posts on stirrups kept out of contact with soil. Timber in contact with ground is conducive to termite infestation and timber fungal decay.

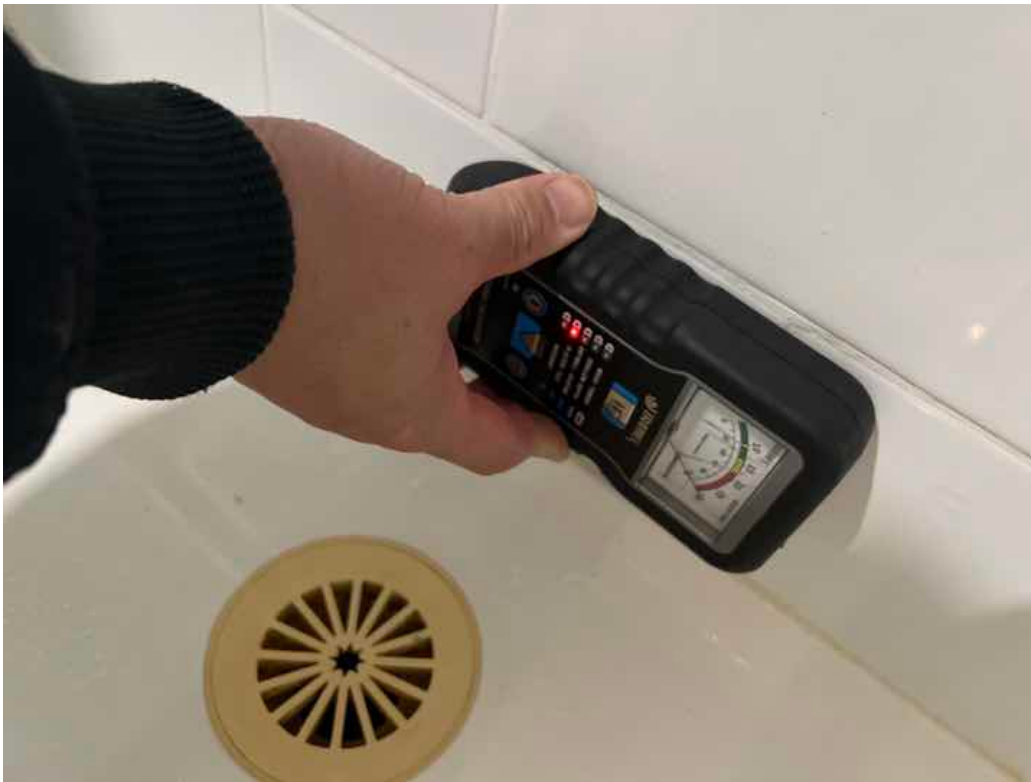
High Moisture reading noted in the shower walls. This is likely caused by tile grout deterioration or waterproofing deterioration. No significant water damages have been Noted From Normal viewing position. Typically, Regrouting and resealing should suffice. Engage a waterproofing contractor for further advice.

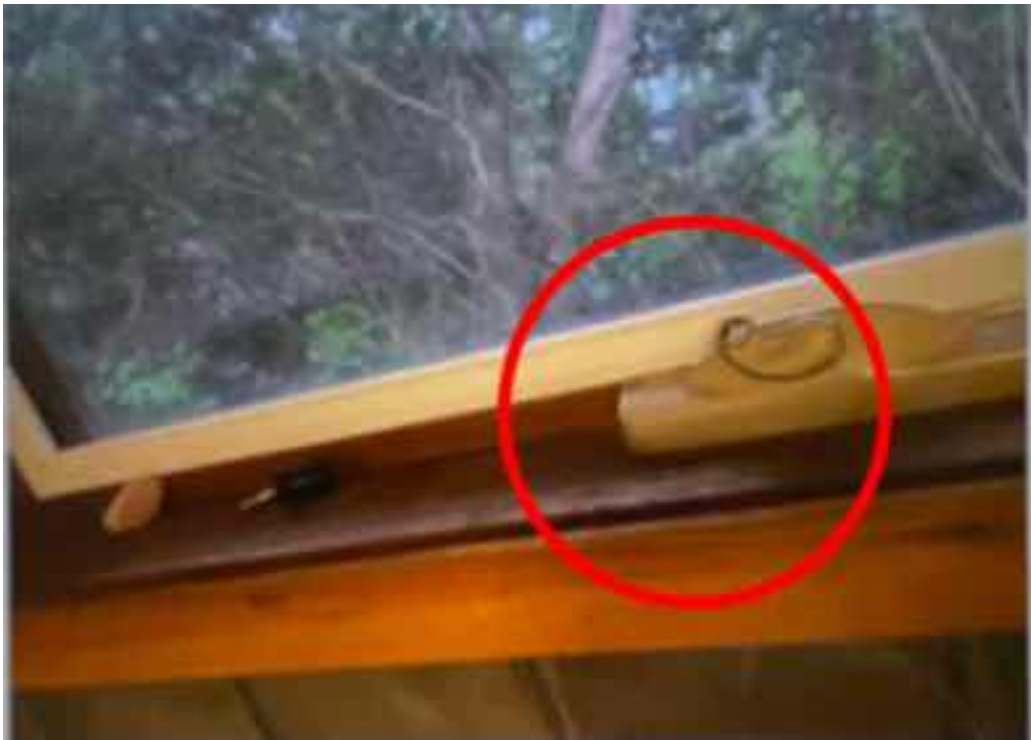
| UPPER LEVEL | Bath Room 1 | Windows | Upon visual inspection, the window mechanism was found to be faulty, causing improper sealing and difficulty in operation. Recommend engaging a licensed tradesperson to replace or repair the mechanism to ensure smooth functionality and proper sealing. This will enhance energy efficiency and prevent potential water ingress. Regular maintenance checks are advised to prolong the window's lifespan and maintain optimal performance. |

Upon visual inspection, the window mechanism was found to be faulty, causing improper sealing and difficulty in operation. Recommend engaging a licensed tradesperson to replace or repair the mechanism to ensure smooth functionality and proper sealing. This will enhance energy efficiency and prevent potential water ingress. Regular maintenance checks are advised to prolong the window's lifespan and maintain optimal performance.

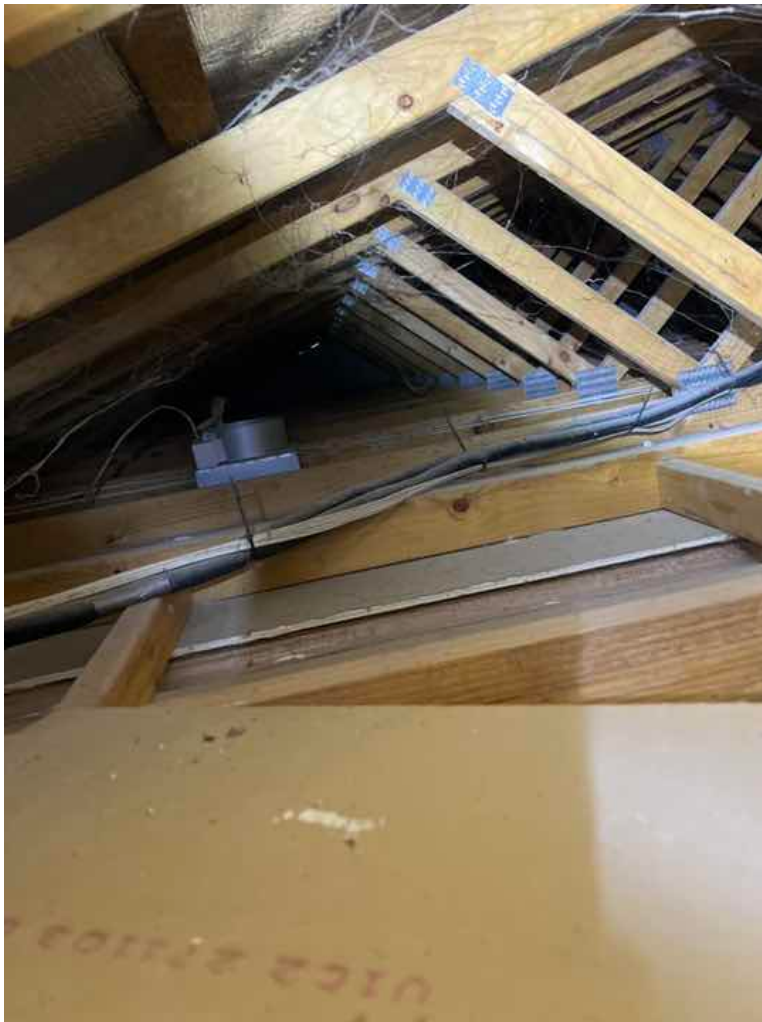
No insulation installed. Recommendations: Engage insulation contractor to assess.

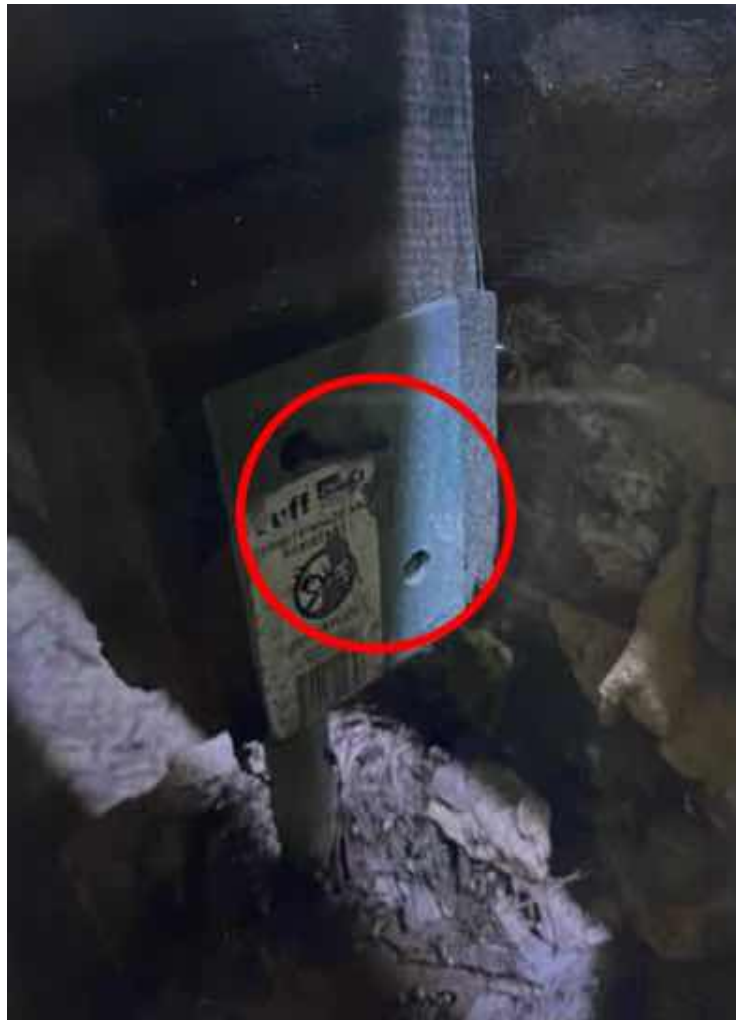
| SUBFLOOR | Sub-Floor Observation. | Piers And Foundation Walls | Not enough fixing on post. Contact a qualified carpenter for assistance. |

Not enough fixing on post. Contact a qualified carpenter for assistance.
