# Sample Pre Purchase Building And Pest Reports

## Apexi Building Inspections Pty Ltd

Report/Agreement # 2707251415093

### Pest And Building Inspection

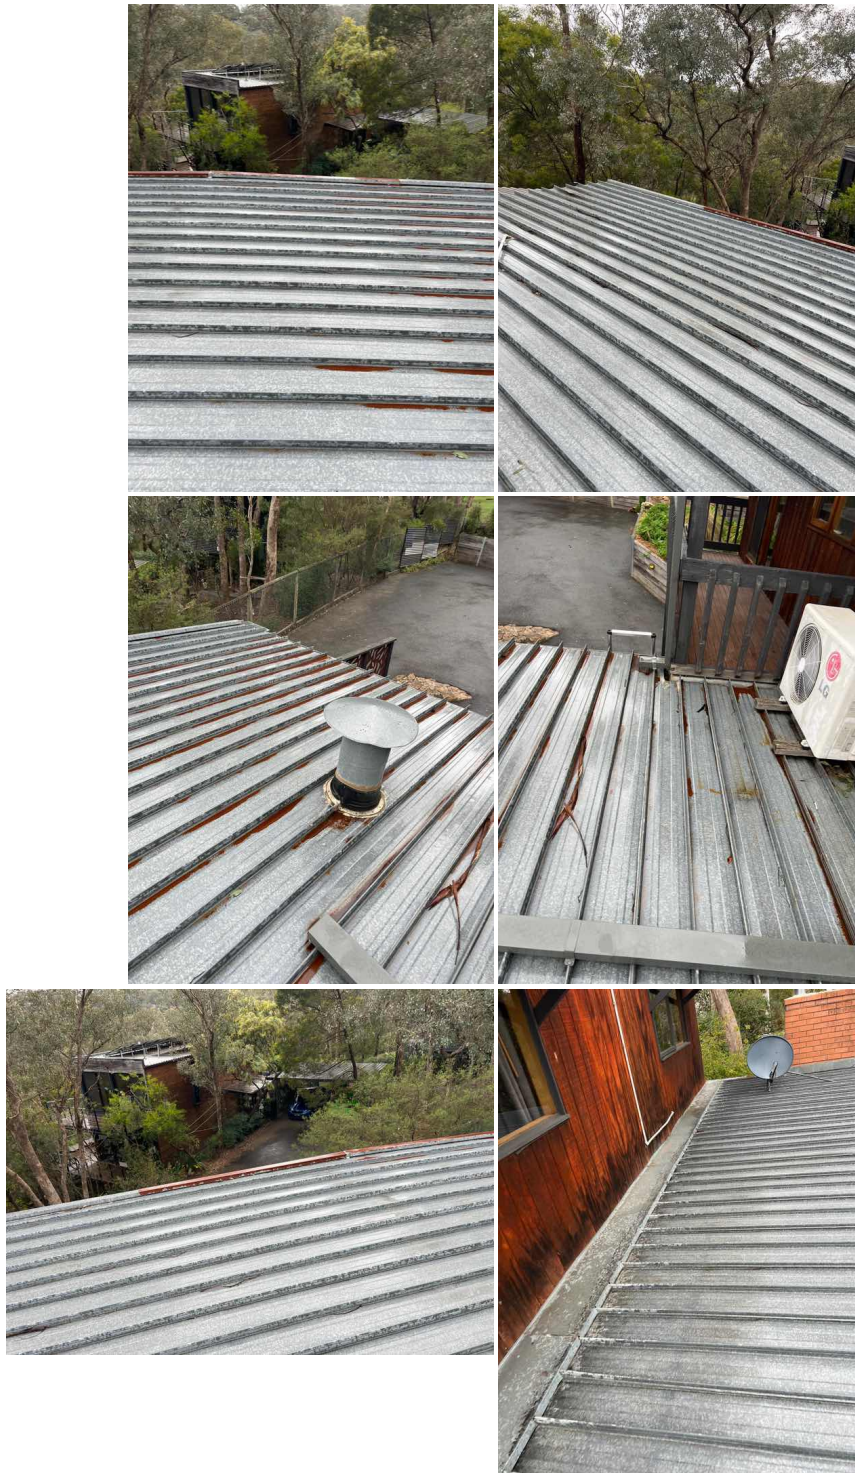
Visible section of The roof cladding appeared in a serviceable condition for the age of this dwelling. Annual maintenance inspection recommended.

Metal roof is rusting and requires or replacement as the may lead to water ingress into the roof cavity. Contact a qualified roofing contractor for immediate repairs.

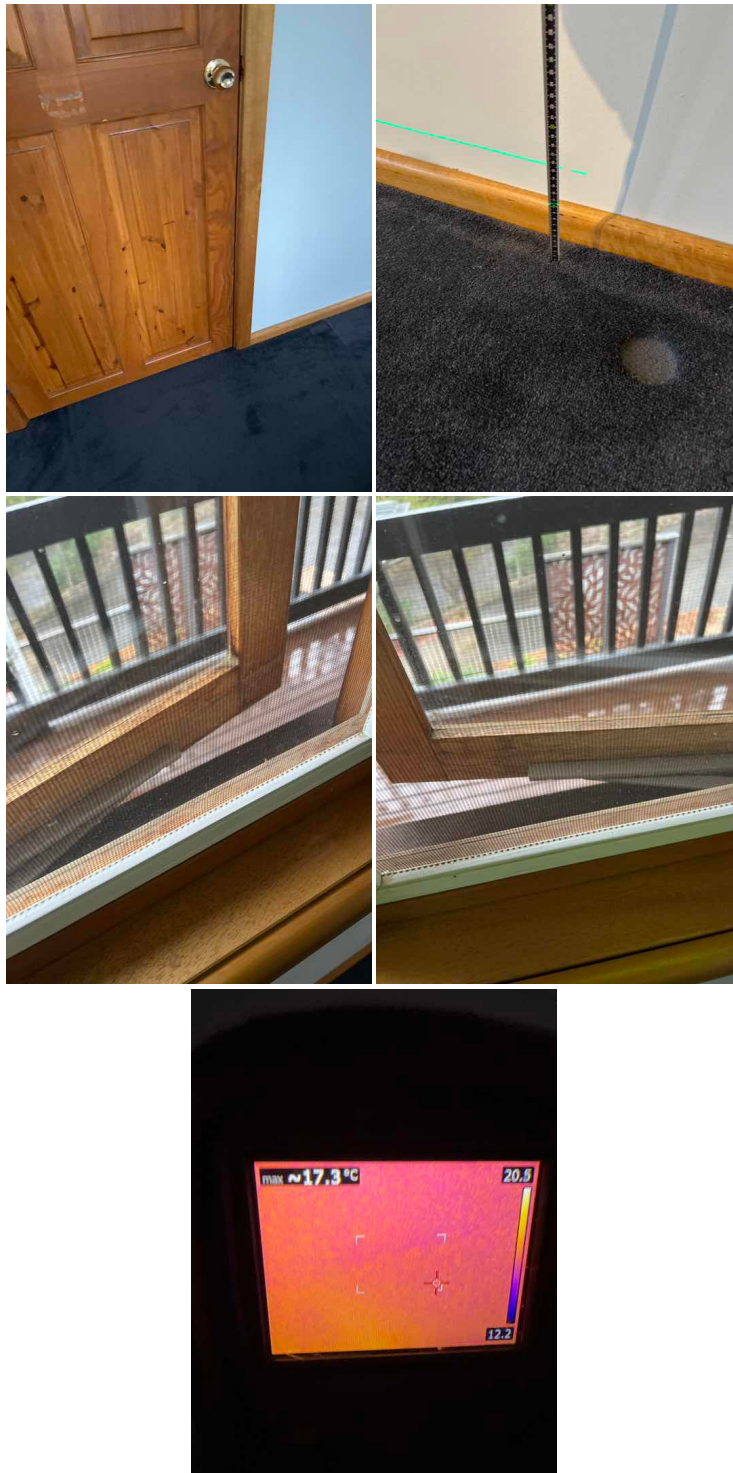
A floor deviation ranging between 10mm and 20mm has been noted in this area. While this deviation is not considered significant and is commonly observed in other buildings, further assessment is recommended to determine its cause and potential implications. Minor deviations such as this can result from various factors, including natural settlement, structural movement, substandard workmanship in flooring installation, and other contributing elements.

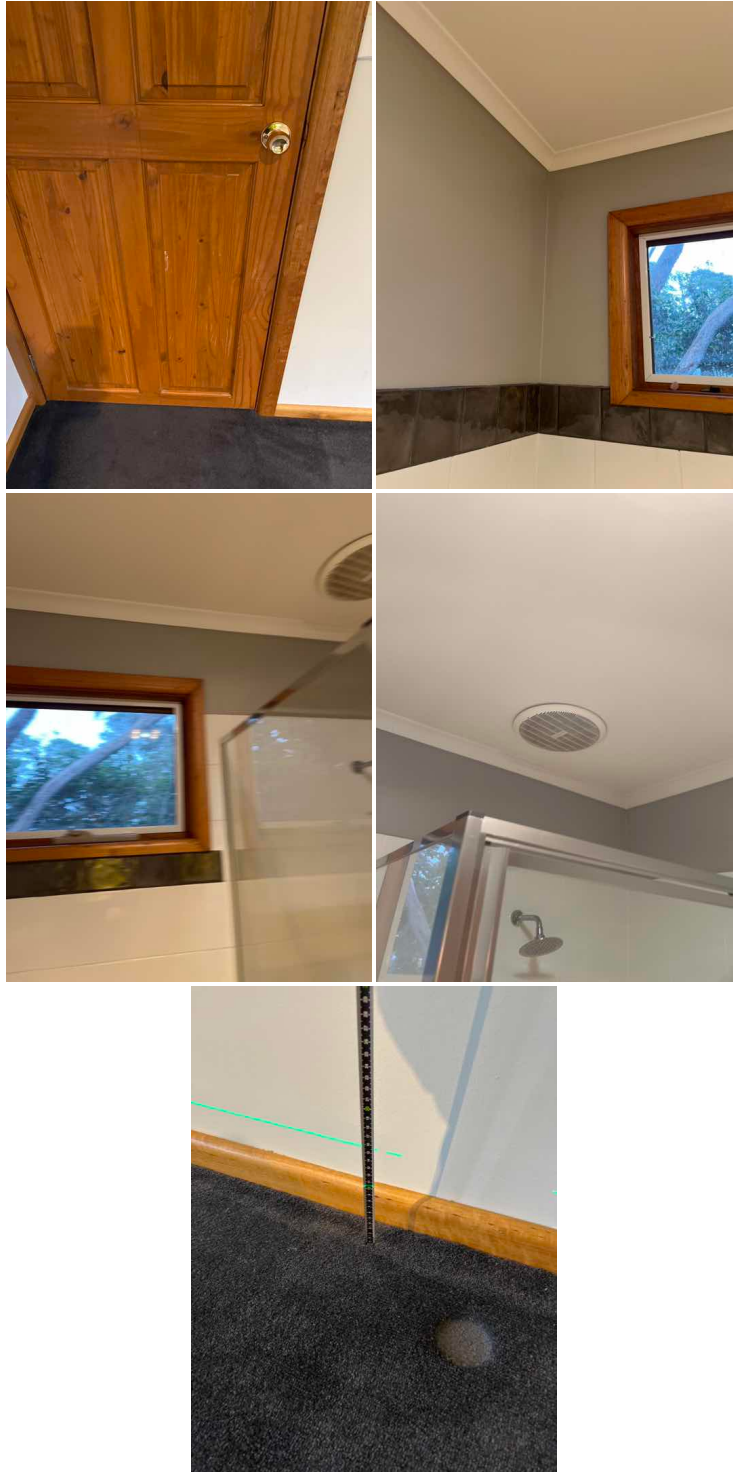
A floor deviation ranging between 10mm and 20mm has been noted in this area. While this deviation is not considered significant and is commonly observed in other buildings, further assessment is recommended to determine its cause and potential implications. Minor deviations such as this can result from various factors, including natural settlement, structural movement, substandard workmanship in flooring installation, and other contributing elements.

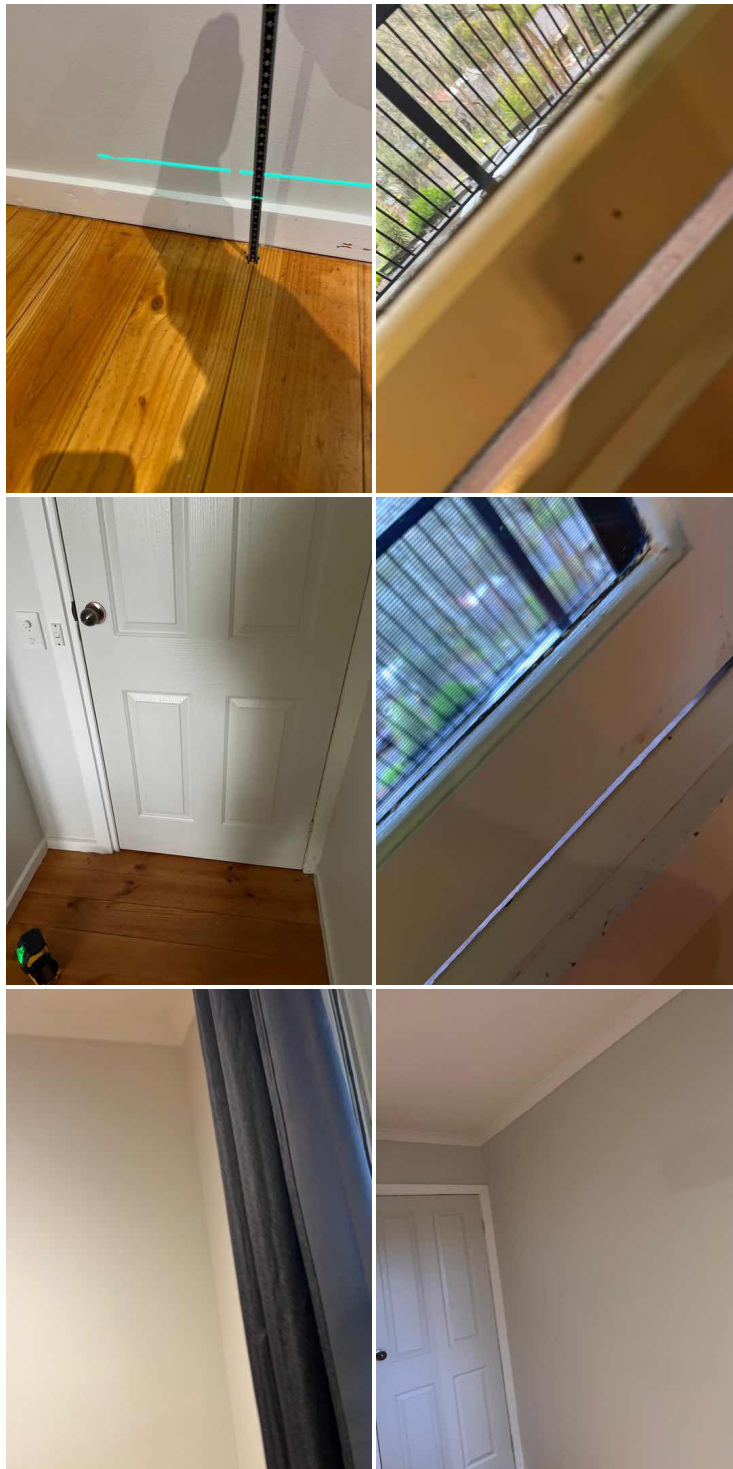
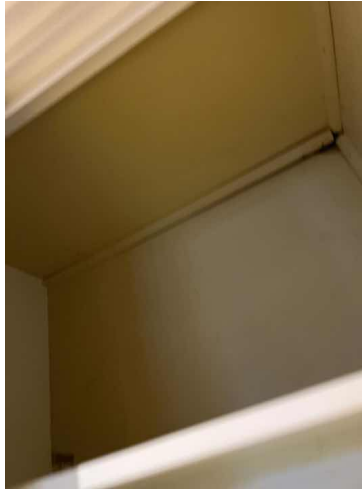
Squeaky floor boards noted. Re-fixing the floor boards may fix this issue.

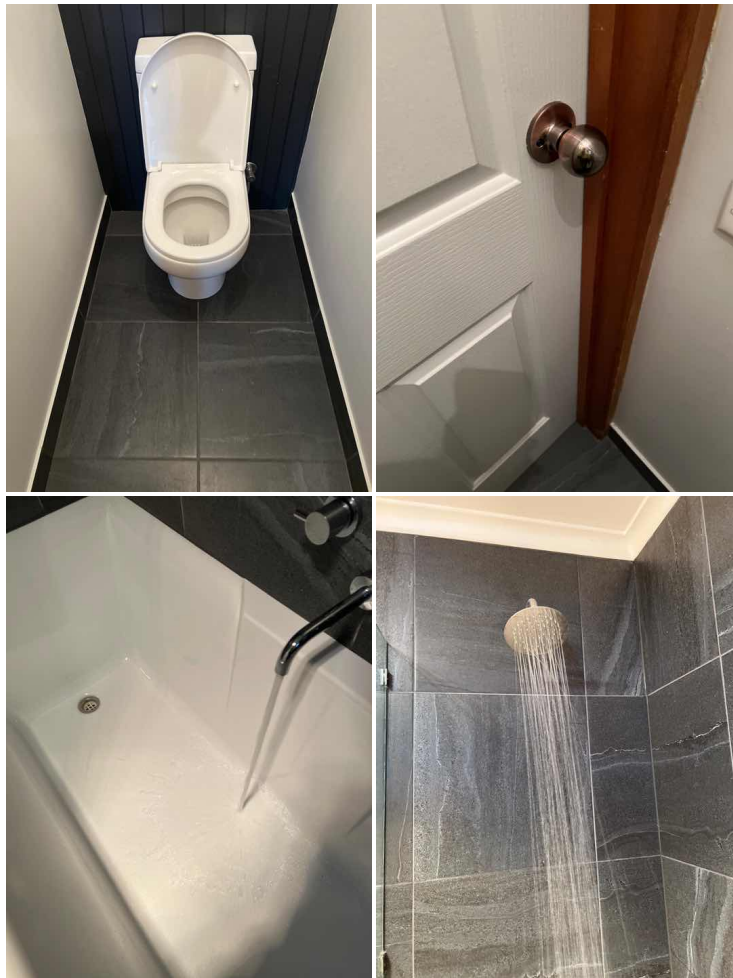
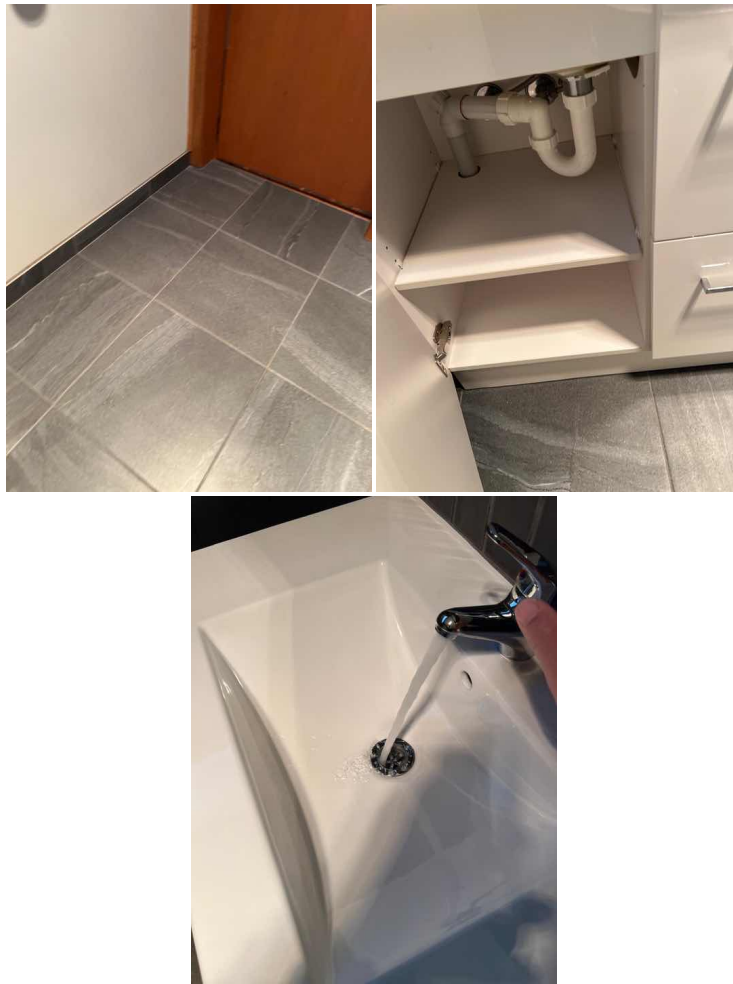
From the visible and accessible areas, this room appears to be in a serviceable condition for the age of the property with no notable structural defects sighted.

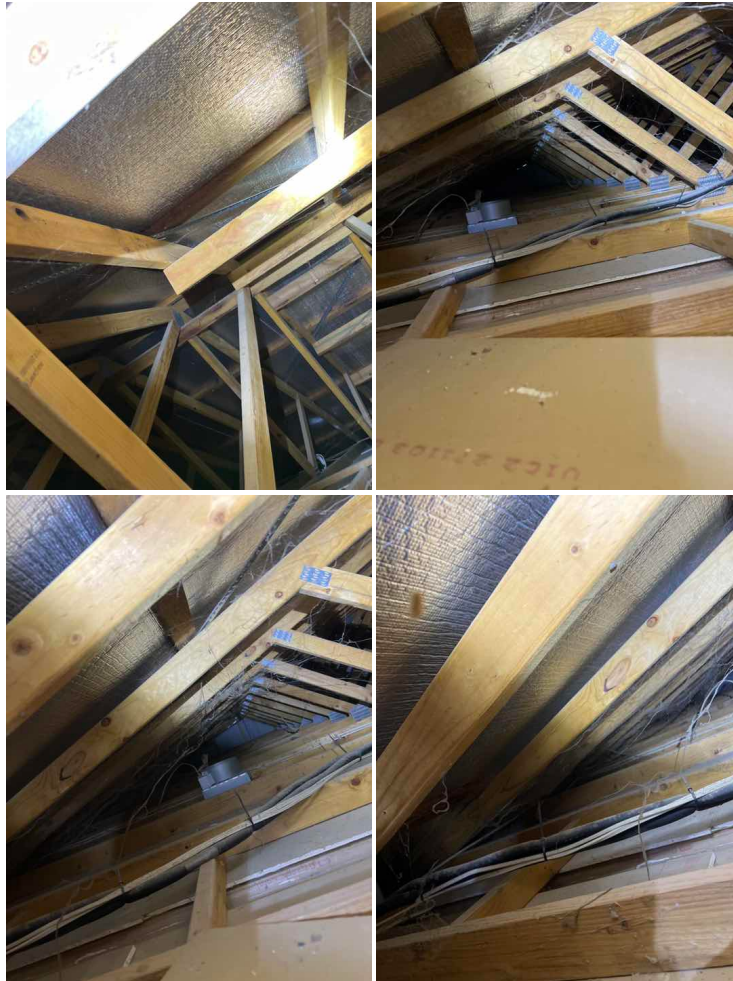
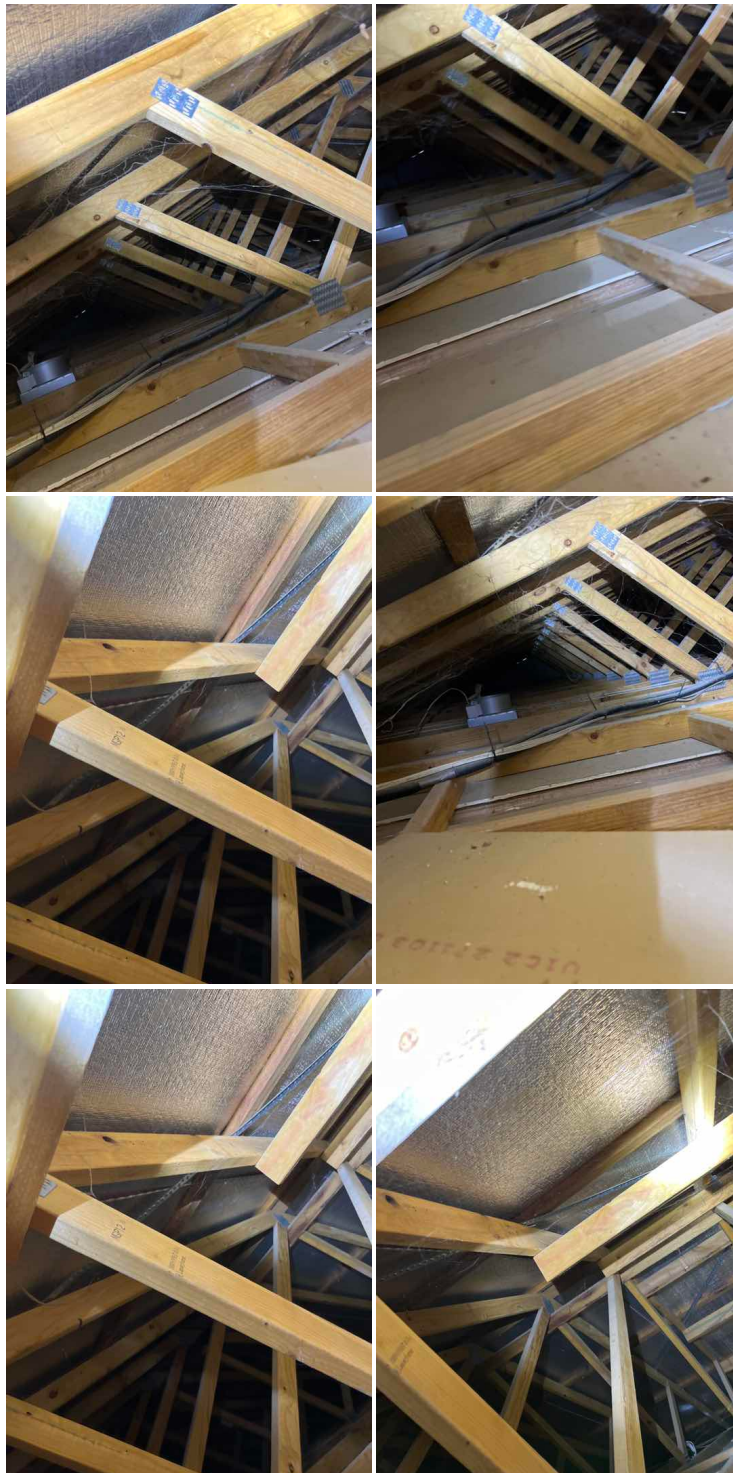
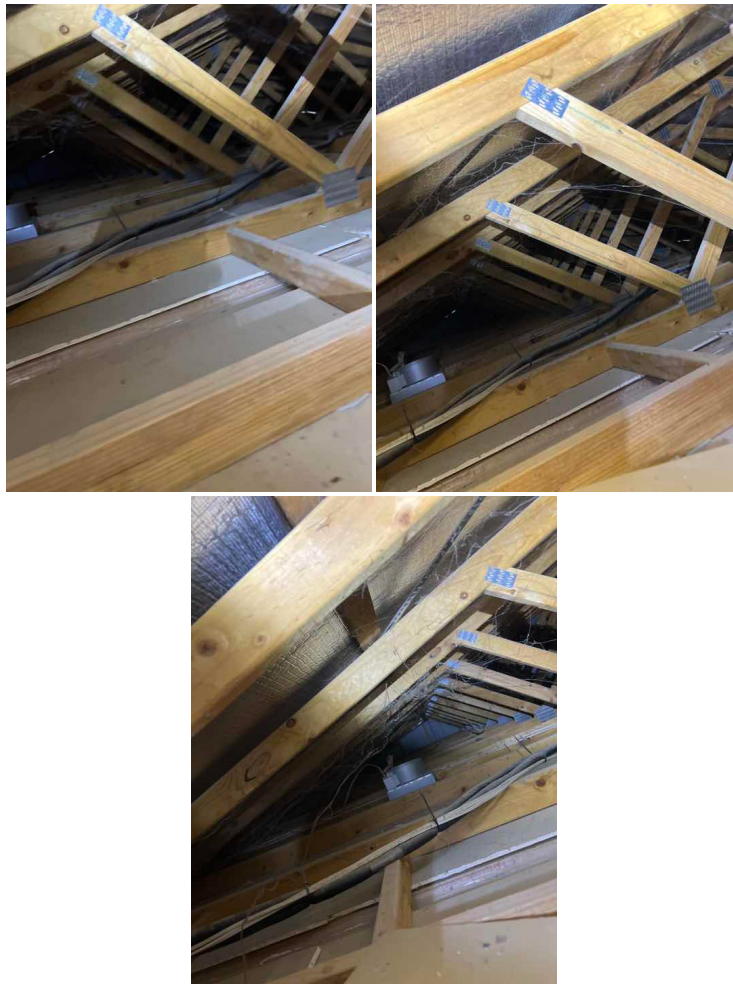
Visible sections of the roof void is in a serviceable condition for age of this dwelling.

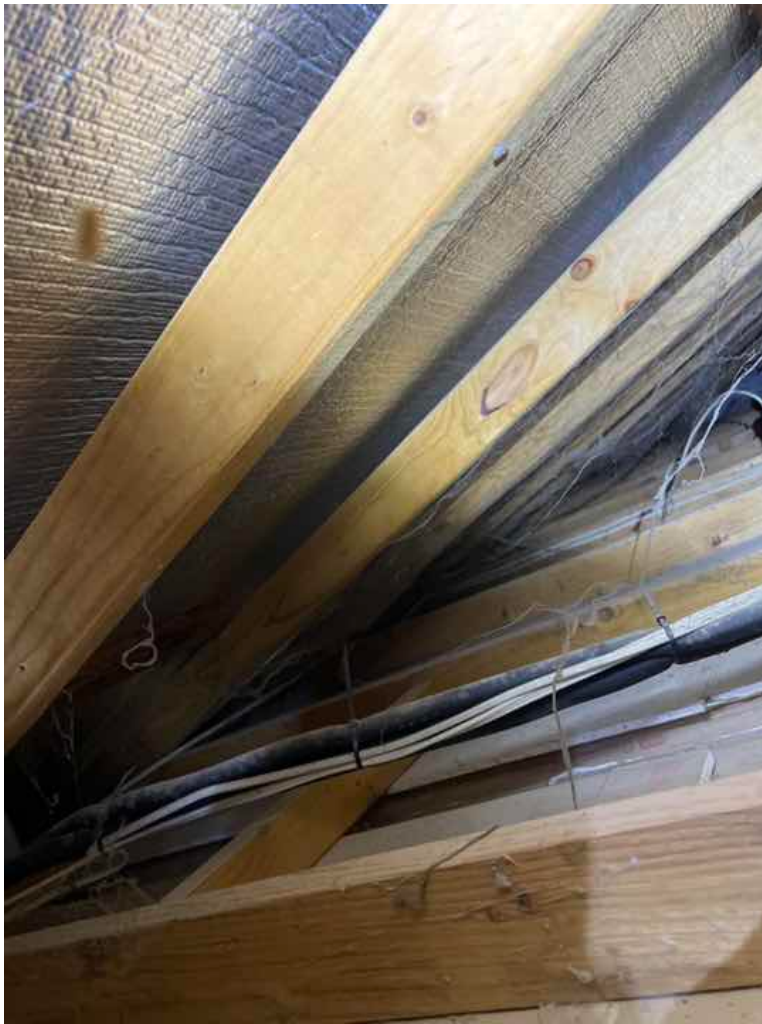
Sarking is installed.

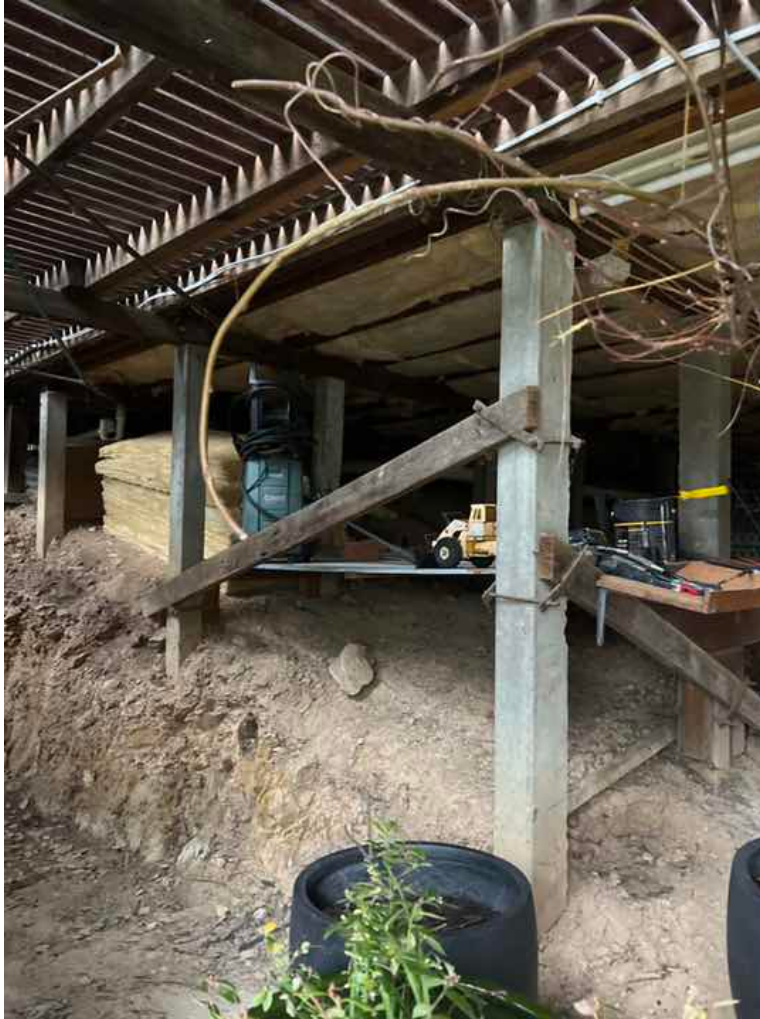
Low access restricted full visual inspection.

Stored items restricted visual inspection.

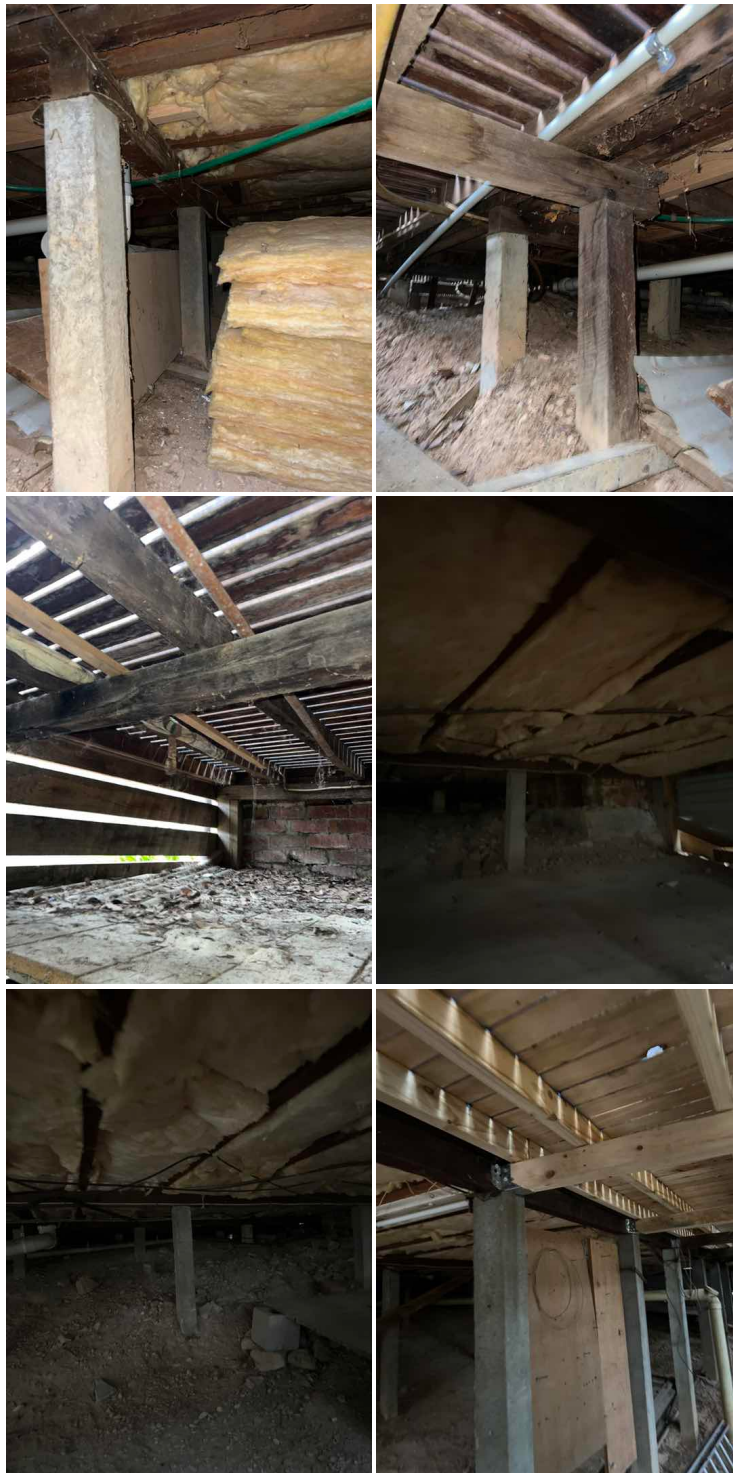
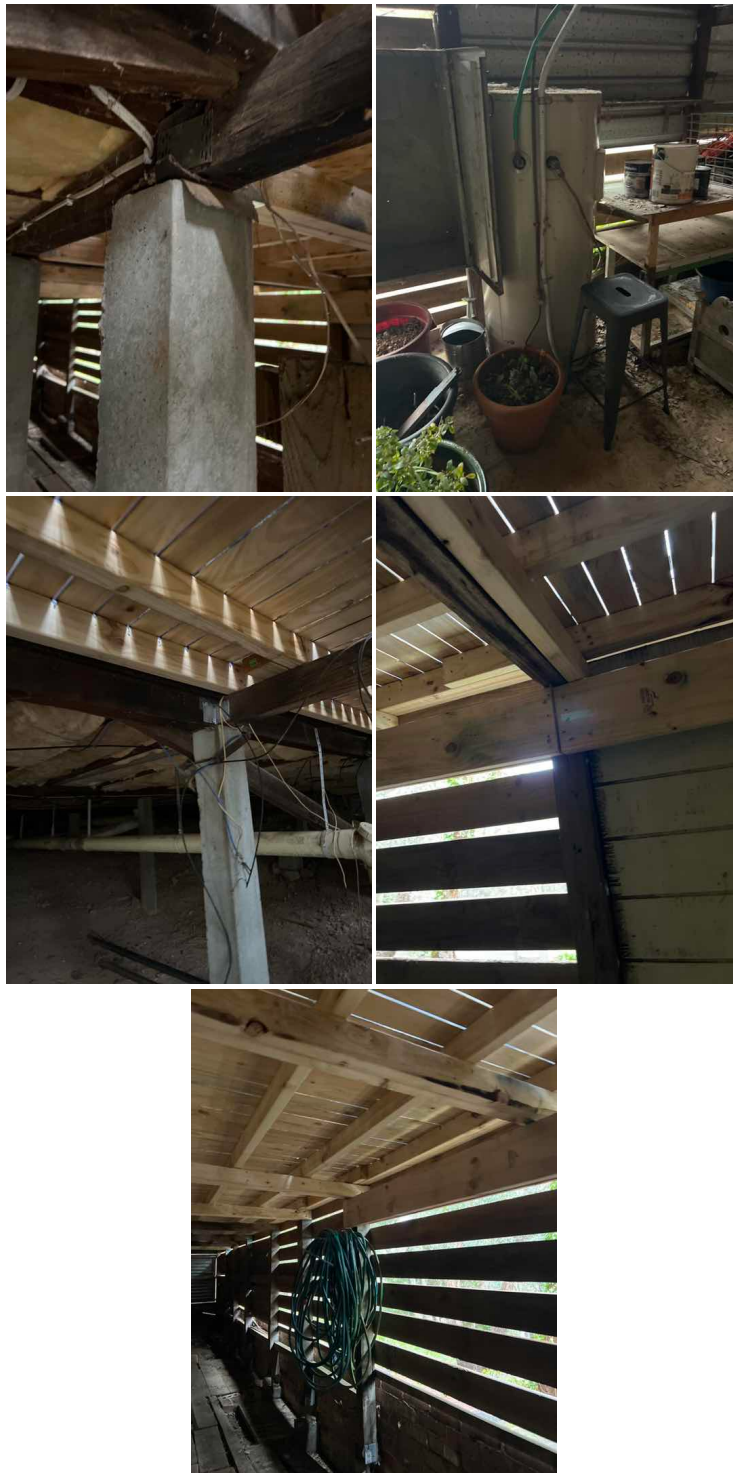
Of areas accessible and visible, the subfloor and components appeared to be in a serviceable condition.
